SUCCESS STORY

MONITORING TILT OF GEDIMINAS' TOWER IN LITHUANIA++

Tilt Monitoring

Loadsensing | Tiltmeter

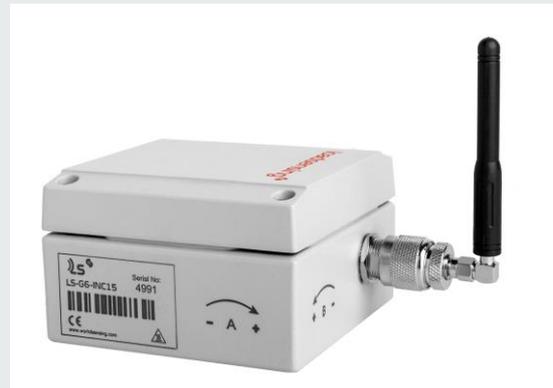
*Figure 2:
Loadsensing Wireless Tiltmeter, a 2-in-one sensor + data node*

Installation of the wireless Loadsensing monitoring system was done in one day on Wednesday January 18th, 2017, with temperatures well below 0°C. GPS Partneris installed the biaxial tiltmeters within 0.5 degrees both in A and B axis, using special brackets designed by Geosense.
