Monitoring tilt at Gediminas' Tower in Lithuania

Tilt monitoring

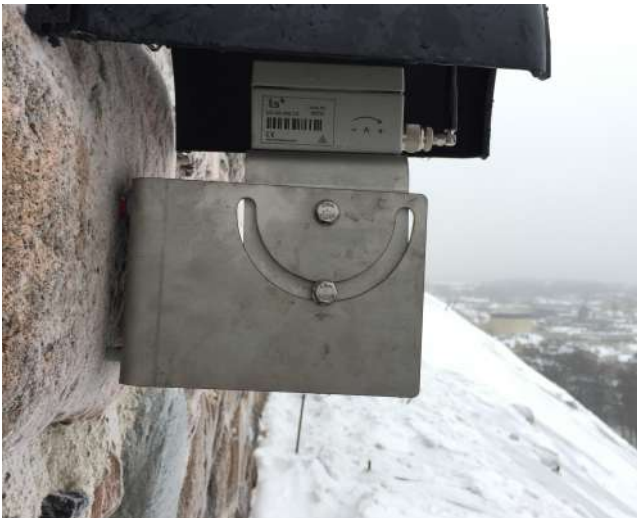
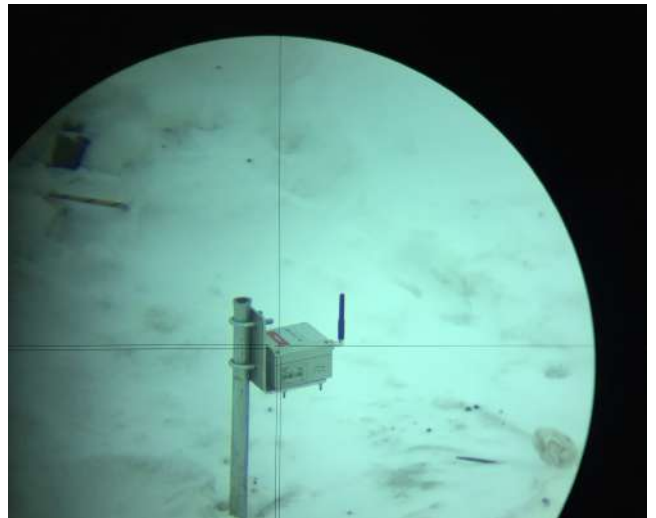
Worldsensing wireless tiltmeter installations

Installation of the wireless Worldsensing monitoring system was done in one day in January, with temperatures well below 0°C. GPS Partneris installed the biaxial tiltmeters using special brackets designed by Geosense.
